**ORLEANS PARISH
DRAINAGE PUMPING STATIONS**

KATRINA DAMAGE REPAIR

**U. S. ARMY CORPS OF ENGINEERS
NEW ORLEANS DISTRICT**

February 15, 2006

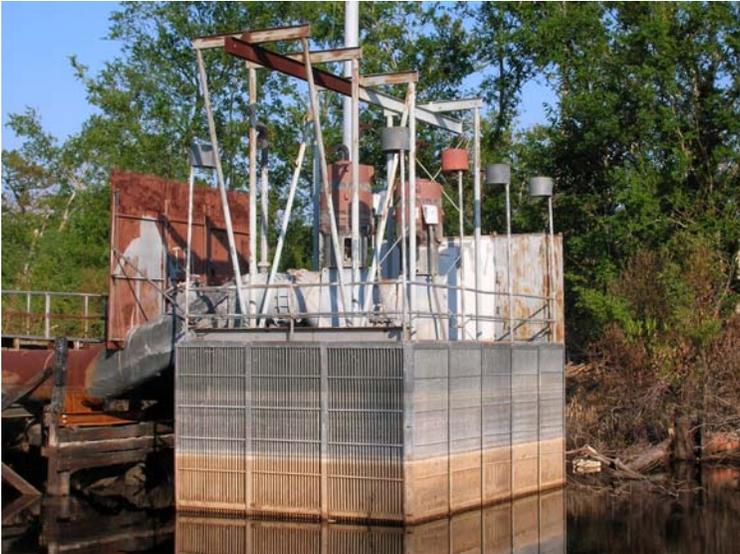
Photo 1 – Pump Station 18

1. The flood water level was below the operating floor level.
2. 30 LF of 6' chain link fence on the outlet structure is damaged. Repairs are recommended.
